UNITED STATES
DEPARTMENT OF THE INTERIOR
GEOLOGICAL SURVEY

FLOODS FROM DAM FAILURES

By John E. Costa

Open-File Report 85-560

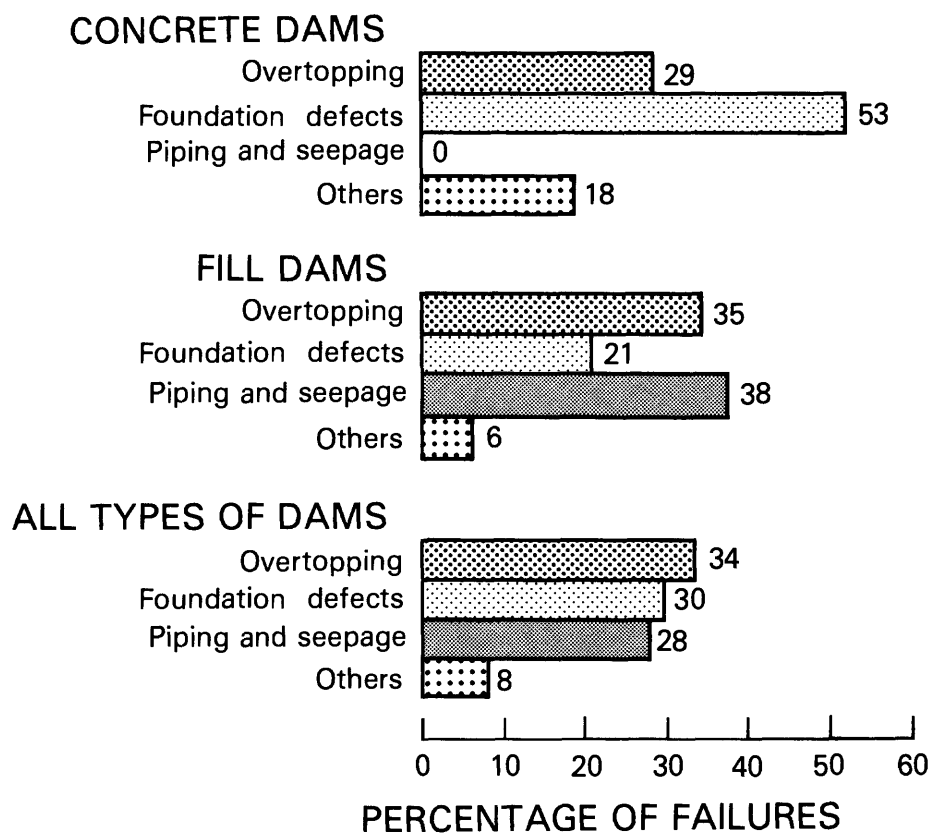
The International Commission on Large Dams compiled a survey of dams more than 15 m in height that failed between 1900 and 1973 (International Commission on Large Dams, 1973). The three main causes of failure were overtopping (inadequate spillway), foundation defects, and piping (fig. 1). The major cause of failure of concrete dams was foundation failure (53 percent), and the major cause of failure of fill or embankment dams was piping and seepage (38 percent). Piping and seepage failures did not occur with any concrete dam. For all dams built, failures by overtopping due to an inadequate spillway (34 percent), foundation defects (30 percent) and piping and seepage (28 percent) have about the same rate of occurrence (fig. 1). These data clearly indicate that the greatest risks of a dam failing originate from ignorance of the magnitude and frequency of extreme floods, and uncertainties of the geologic setting.

Figure 1. Graphs showing causes of failure for different dam types more than 15 meters high (International Commission on Large Dams, 1973).

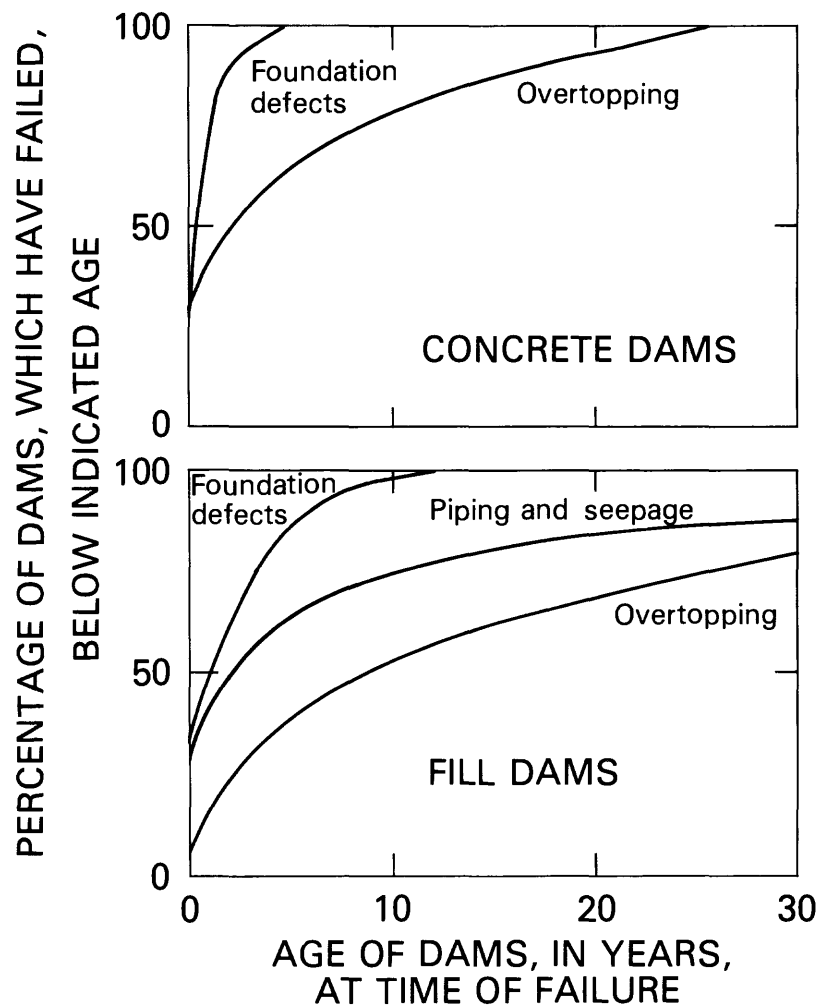
The incidence of the causes of dam failures as a function of the dam's age at the time of failure is shown in figure 2. Foundation failures occur early in a dam's history, whereas other causes take relatively longer to develop. A very large percentage of all dam failures occurs during initial filling since this is the time when design or construction flaws, or latent site defects, will appear.

Figure 2. Graphs showing age of dams at time of failure, for different dam types more than 15 meters high (International Commission on Large Dams, 1973).

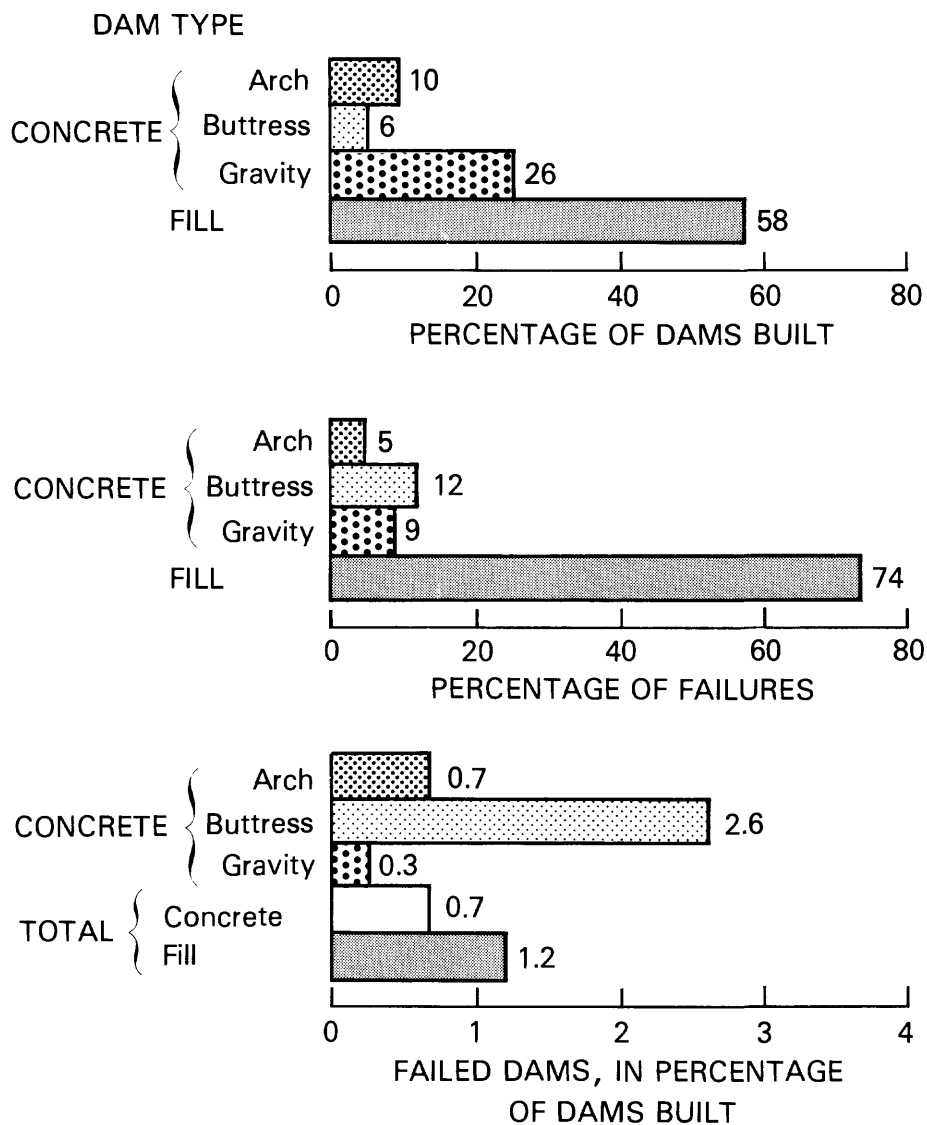
The percentage of different kinds of dams built in western Europe and the United States between 1900 and 1969 is shown in figure 3. Fill or embankment dams (50 percent) were the most numerous types built, gravity dams were second (26 percent). The percentage of failures that occurred for the four different types of dams is summarized in figure 3. Nearly 75 percent of the dams that failed were fill dams. However data in figure 3 also show the failed dams as a percentage of the dams built, and indicates that gravity dams were the safest, followed by arch and fill dams. Buttress dams have the poorest safety record; however, they were the least used.

Figure 3. Graphs showing types of dams built in Western Europe and the United States, and their failure percentage, between 1900-69 (International Commission on Large Dams, 1973).

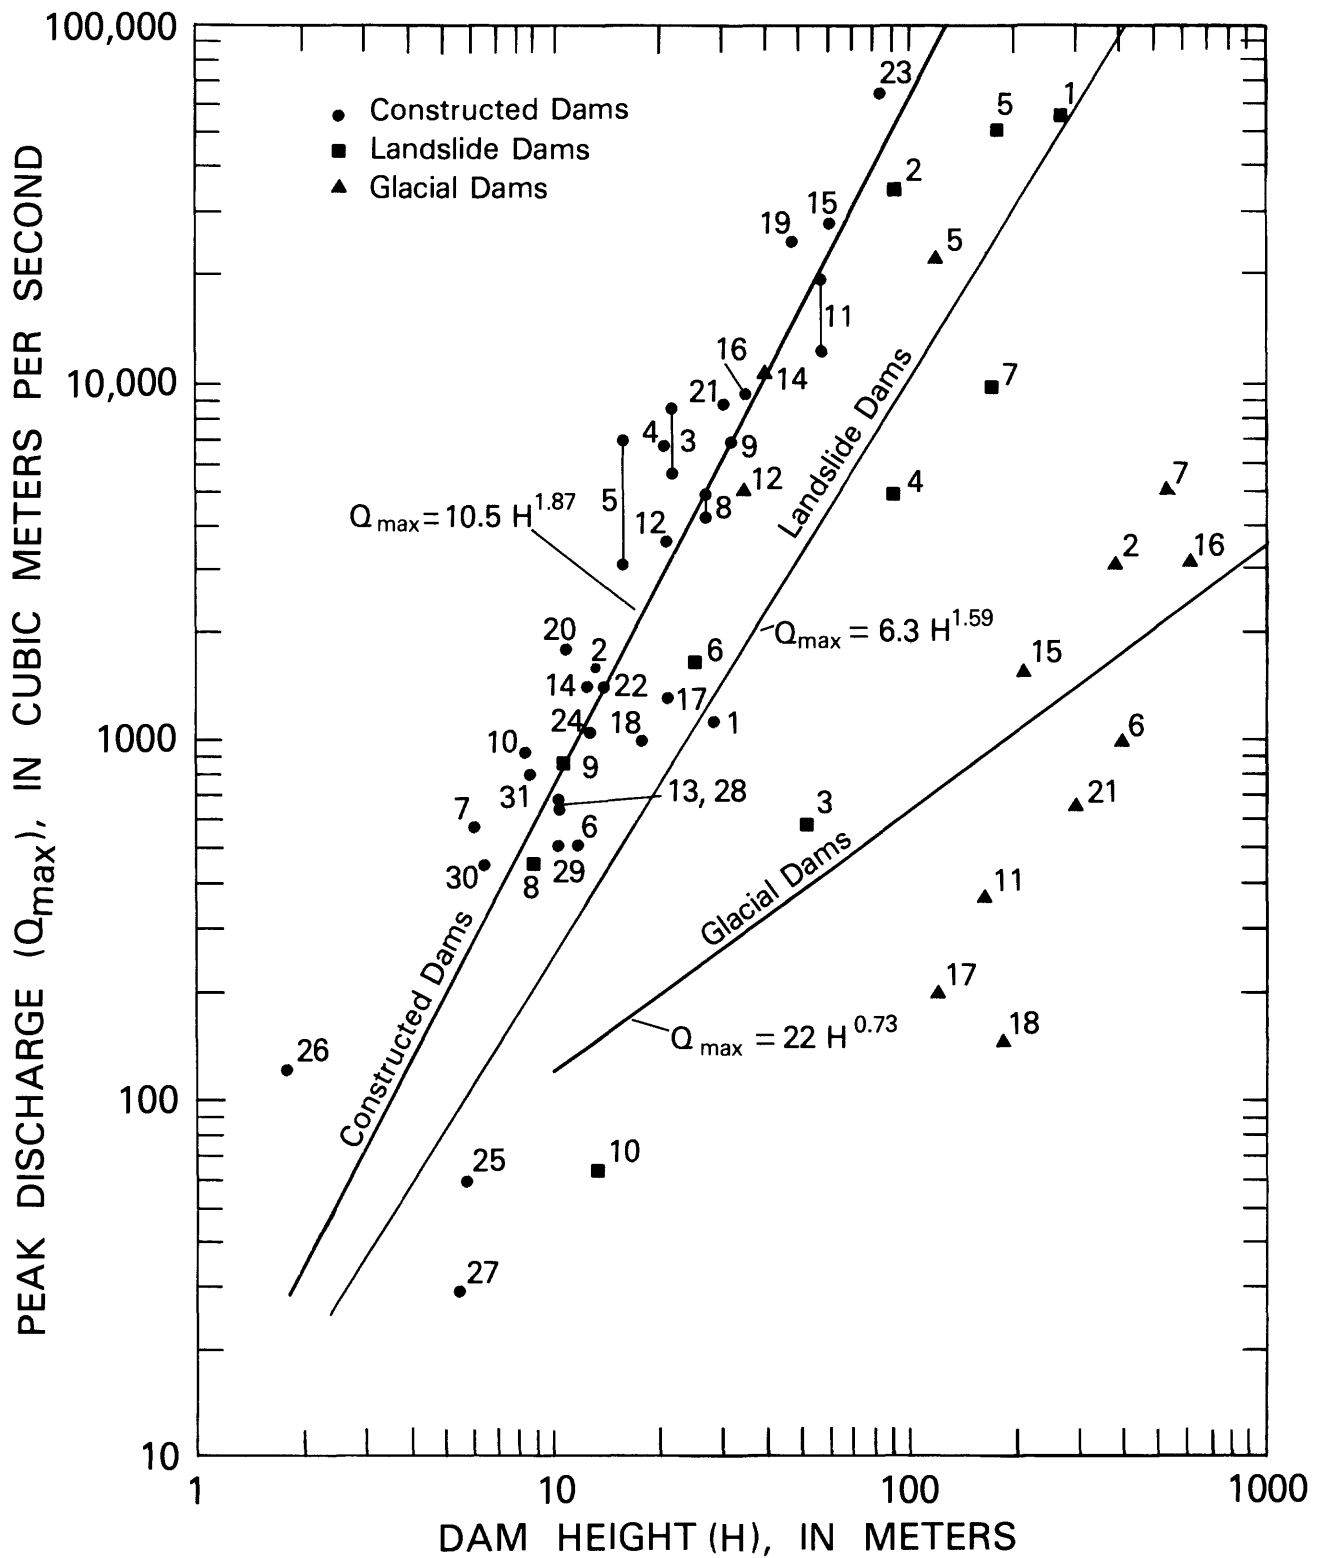
Dam height versus peak discharge for 31 failures of constructed dams between 1.8 and 84 m high is plotted in figure 4 and, listed in table 3. An envelope curve for flood peaks from all the constructed dams has the equation

Accuracy of many peak-discharge estimates from dam failures is questionable, and errors of one order of magnitude may exist. If a rapid, conservative assessment of the potential peak discharge from a failed dam is desired, then the envelope curve (equation 3) could be used. If the purpose is to compare flood peaks from failures of different types of dams, or to reconstruct past flood peaks from old, failed dams for paleohydrological or sedimentological investigations, then a regression equation is more appropriate. A regression equation using dam height as the independent variable has been developed from the data in table 3, and plotted in figure 4. The equation is:

Figure 4. Graph showing dam height (H, in meters) versus peak discharge (Q_{\max} in cubic meters per second) for constructed, glacial, and landslide dams with numbers keyed to tables 3, 5 and 6.

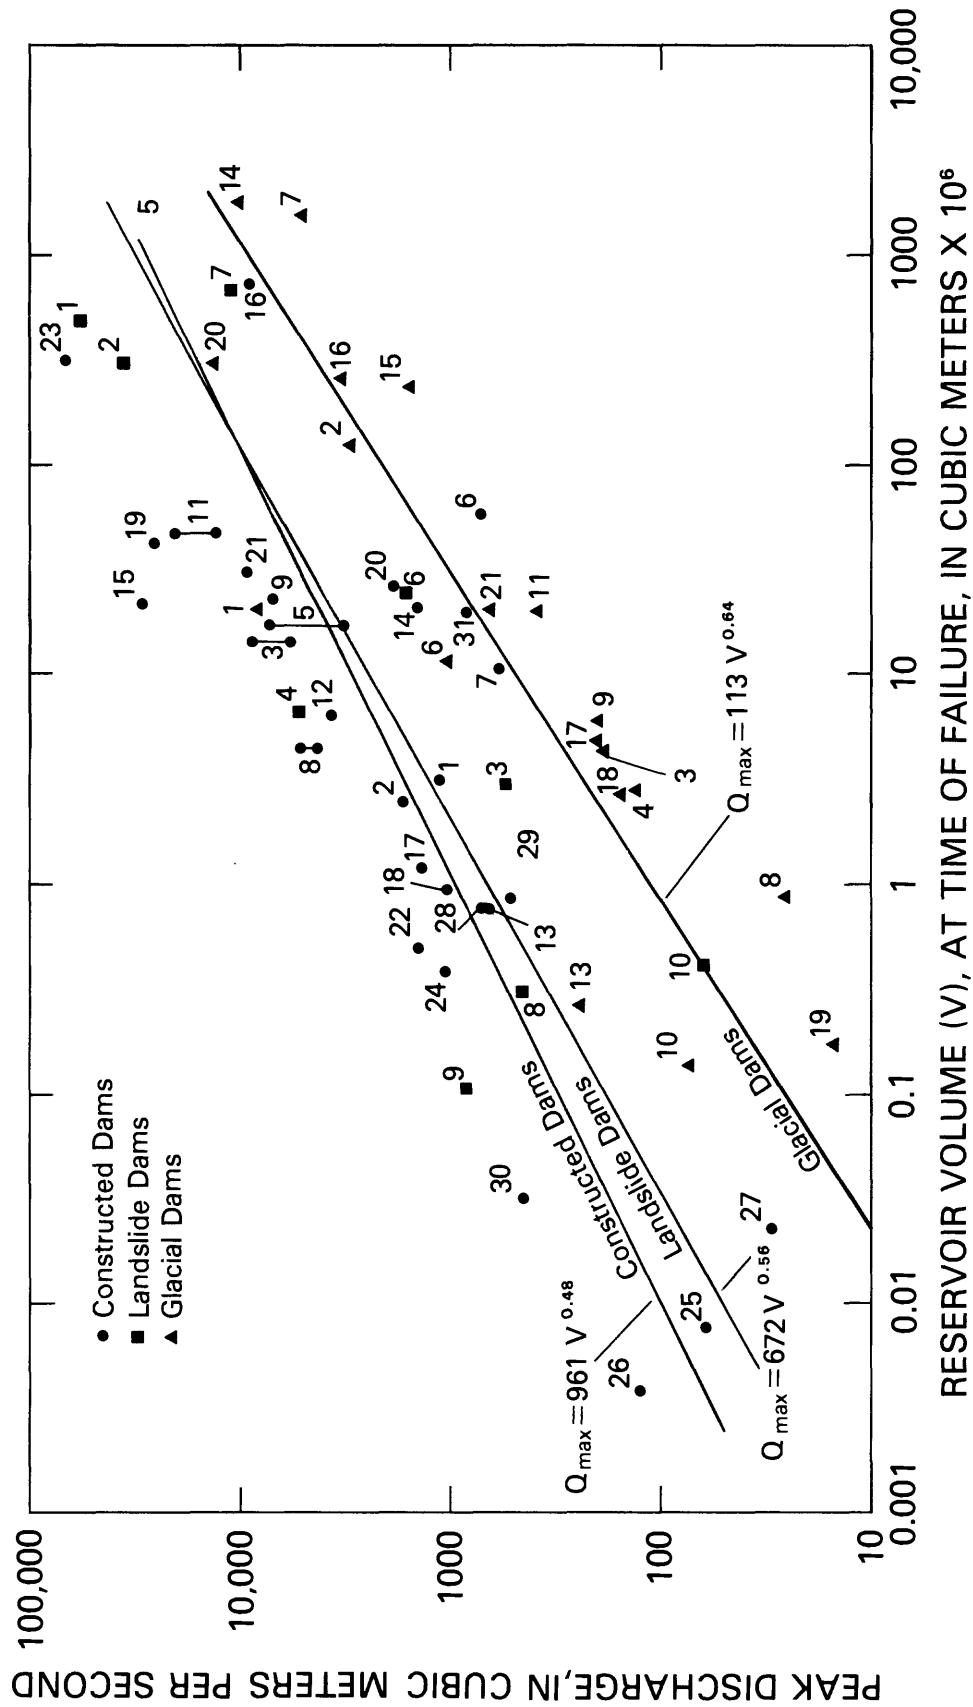
A plot of reservoir volume at time of failure versus peak discharge is shown in figure 5. Sensitivity studies have indicated that reservoir volume as well as dam height are critical factors in the magnitude of dam-failure hydrographs (Hagen, 1982; Petrascheck and Sydler, 1984). An envelope curve encompassing all the data points except two (Malpasset Dam, France, point no. 15, and Cascade Lake Dam, Colorado, point no. 30) has the form:

The Malpasset Dam was a high concrete-arch structure and Cascade Lake Dam was a concrete-gravity dam. These kinds of dams are more susceptible to rapid failure than most of the other types. The sequence of the toppling failure of Cascade Lake Dam, Colorado, is shown in figure 6. The inflow flood peak leading to the failure was 45 percent of the outflow peak following the failure.

Figure 5. Graph showing reservoir volume (V , in $\text{m}^3 \times 10^6$) versus peak discharge (Q_{\max} in cubic meters per second) for constructed, glacial, and landslide dams with numbers keyed to tables 3, 5 and 6.

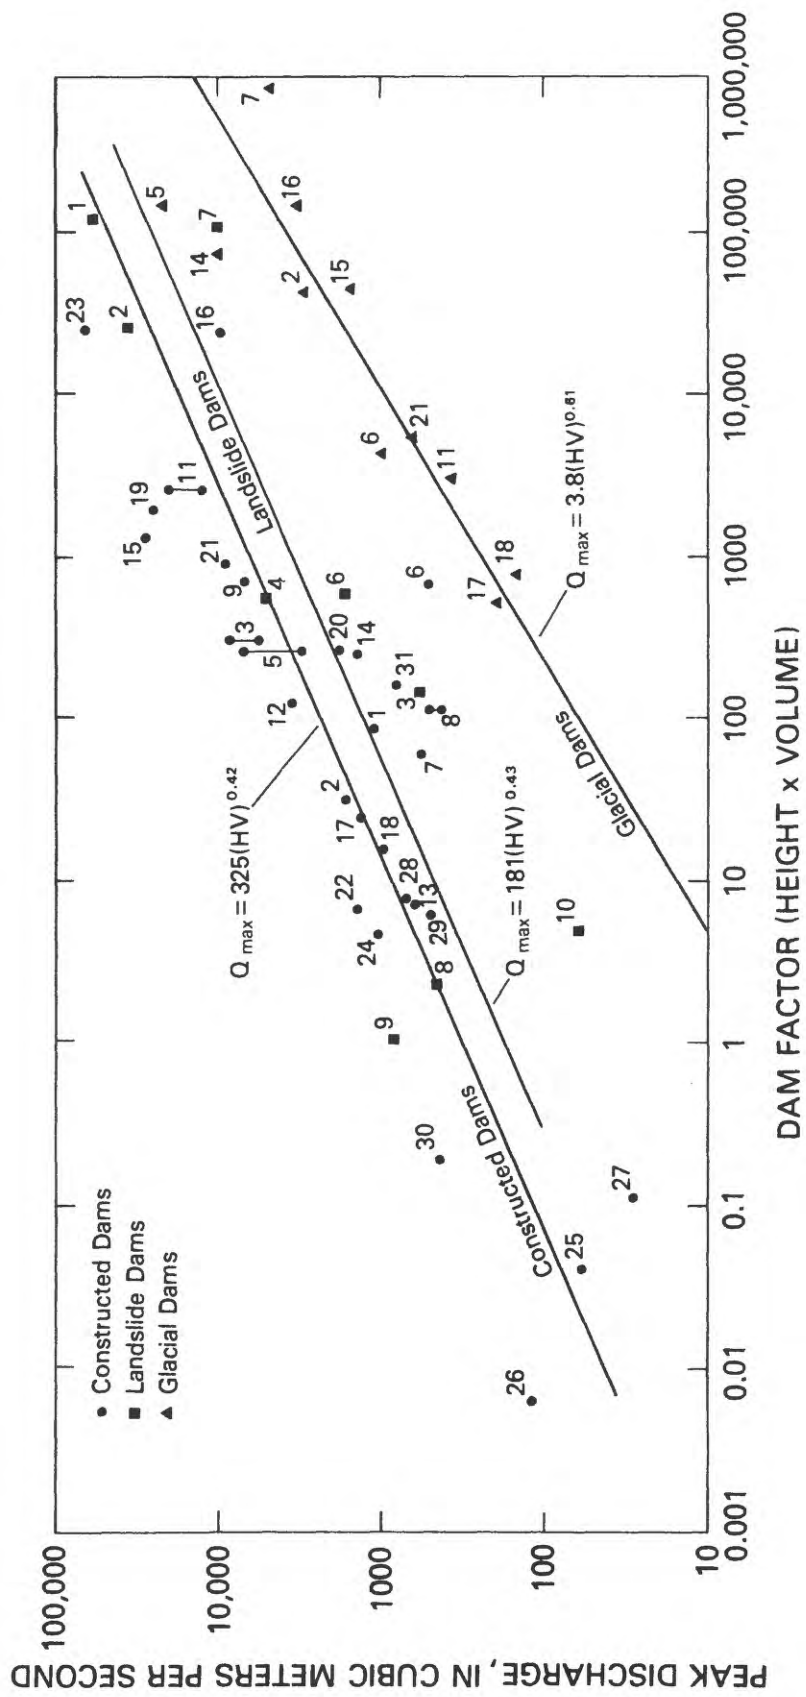
where V is reservoir volume in $m^3 \times 10^6$, and H is dam height, in meters. The regression curve is plotted in figure 7.

Figure 7. Graph showing dam-factor ($H \times V$) versus peak discharge (Q_{\max}) for 29 dam failures with numbers keyed to table 3, 5 and 6.

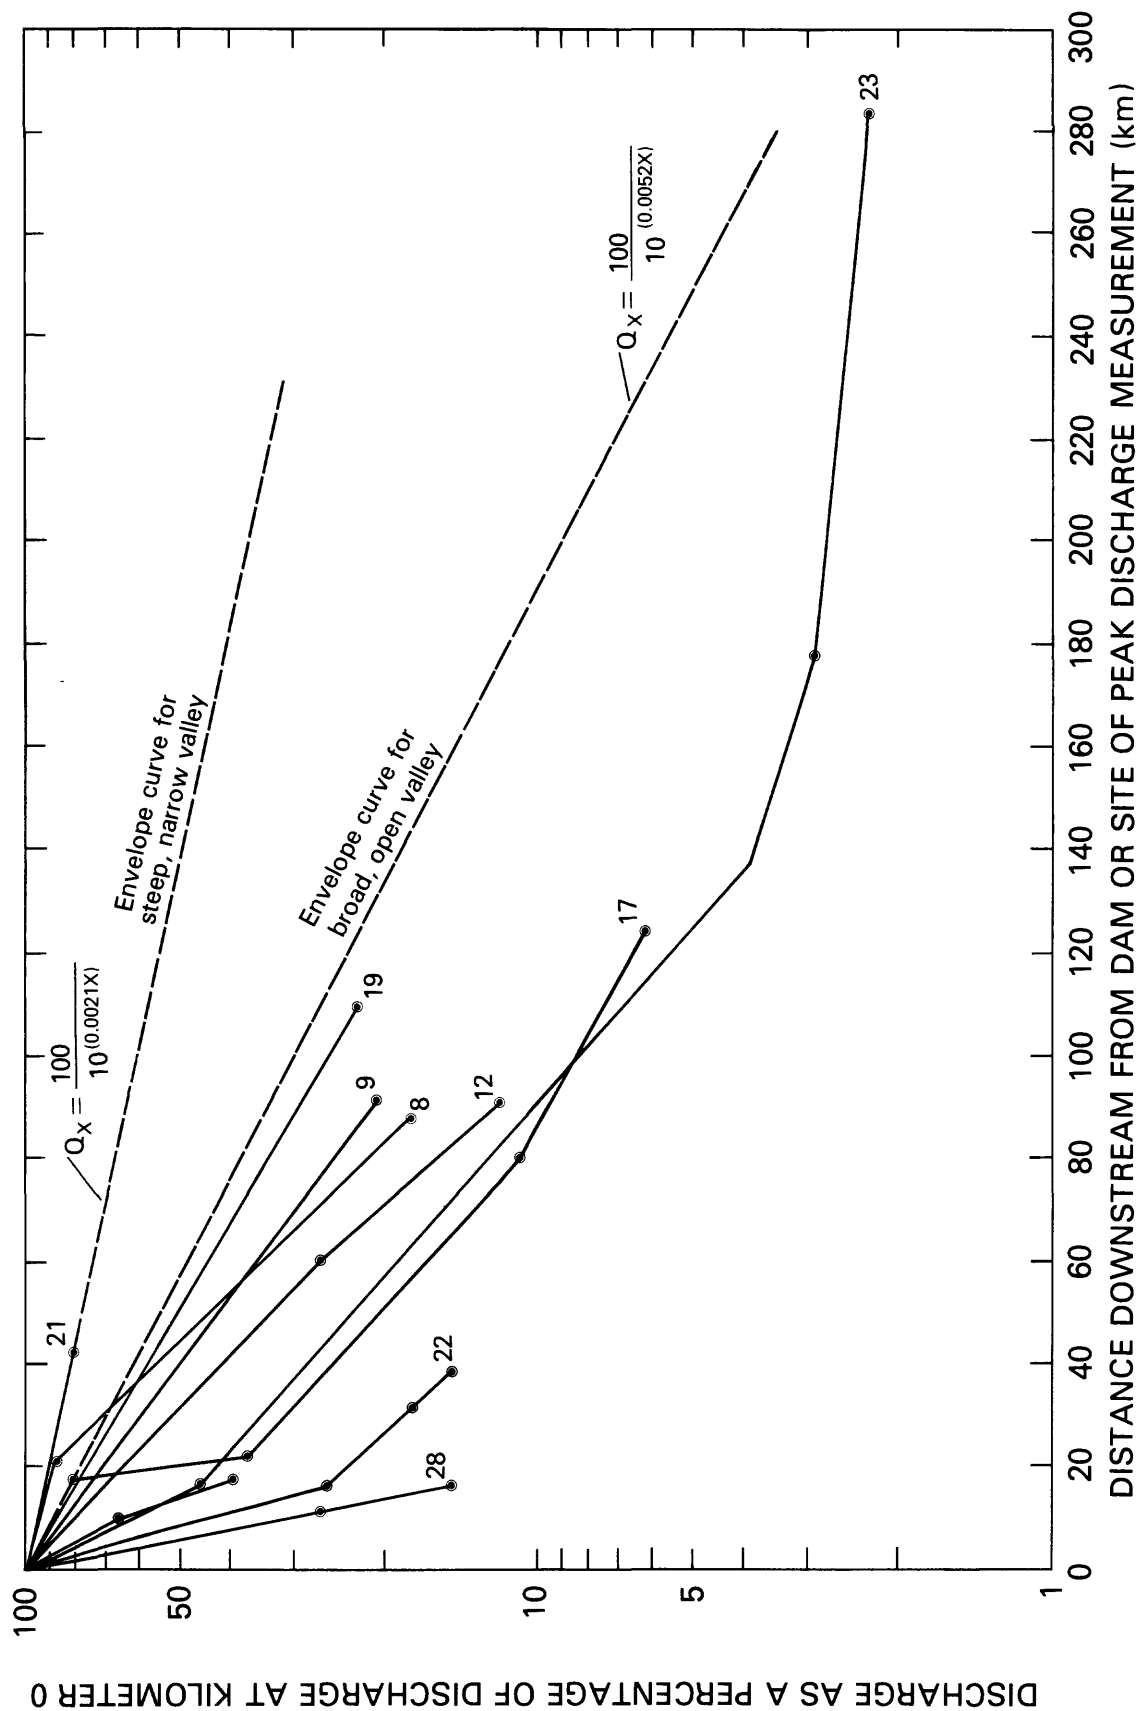
An analysis of some failed dams for which downstream hydraulic measurements were made allows an estimate of attenuation rates based upon empirical data. Available downstream flow data from some failed dams are listed in table 4. Downstream peak discharges are related to peak discharge from the dam failure, and downstream distance from the dam. Attenuation rates as a percentage of upstream discharge are plotted against distance downstream in figure 8. A conservative envelope curve that encompasses all plotted data points for constructed dams, and includes steep, narrow downstream valleys is:

Figure 8. Graph showing attenuation rates of floods from selected dam failures, with numbers keyed to table 4.

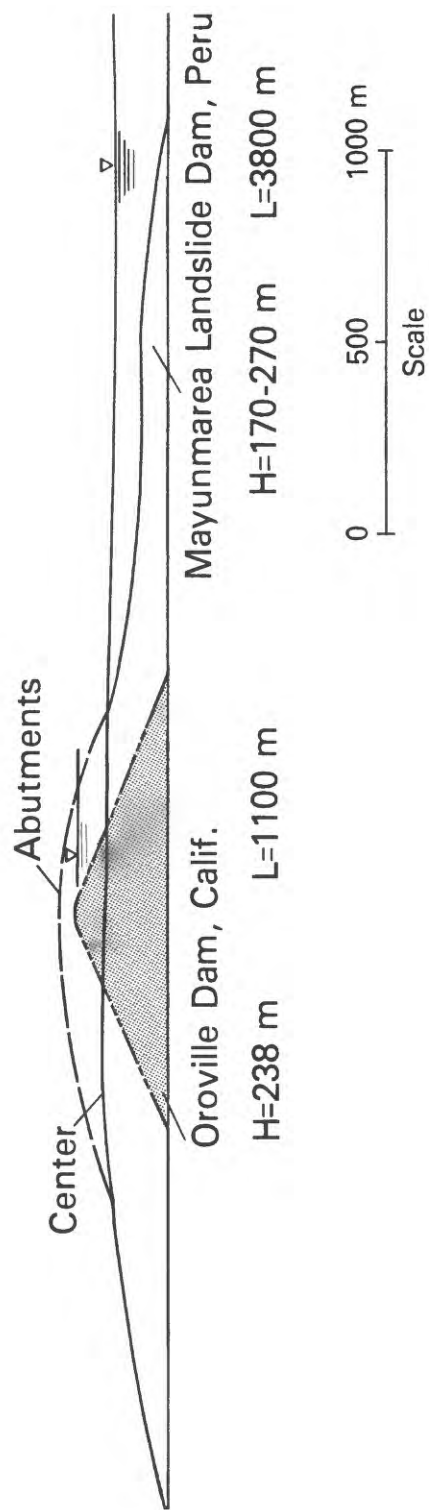
Landslide dams are different from constructed fill dams in several important aspects. Landslide dams are a heterogenous mixture of rock and soil whose permeability can vary greatly. Commonly landslide sediments will plug the valley and flow or slide for some distance down-valley. Landslide dams are typically much wider than constructed dams. For example, the South Nation River landslide dam in Canada was 2.5 km wide (Eden and others, 1971). A transverse section of the Mayunmarca landslide dam in Peru is compared with the Oroville Dam, a large earthfill dam in California in figure 12. The landslide dam is higher at the abutments and almost as high as the constructed dam in the center, but over three times as wide. Landslide dams typically involve large volumes of sediment. The Madison Canyon landslide that dammed the Madison River forming Earthquake Lake in 1959, had a base width five to eight times as great as would have been used in building a rock-fill dam of the same height (Knight and Bennett, 1960).

Figure 12. Cross-section of Mayunmarca landslide dam, Peru, compared to the maximum cross-section of a large earth-fill dam at Oroville, California. (from Lee and Duncan, 1975).

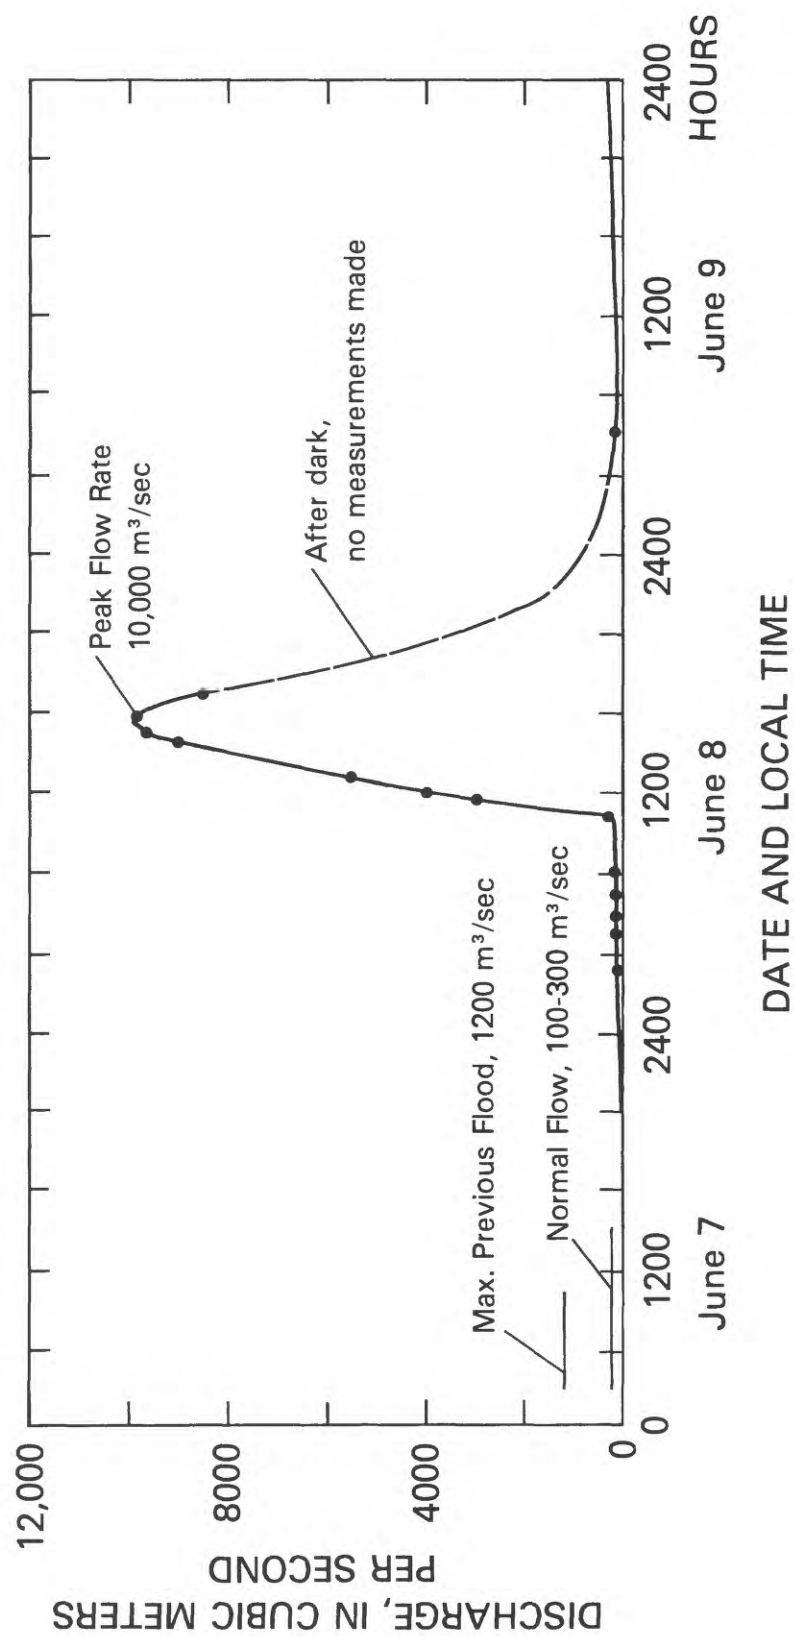
Hydrographs resulting from landslide dam failures depend on the rate of breach erosion and reservoir characteristics. A hydrograph for the 1974 Mayunmarca landslide dam failure in Peru is shown in figure 13.

Figure 13. Hydrograph of discharge resulting from the 1974 failure of Mayunmarca landslide dam, Peru. (from Lee and Duncan, 1975).
